**JOINT BASE MYER – HENDERSON HALL
MUNICIPAL SEPARATE STORM SEWER SYSTEM (MS4)
PROGRAM PLAN**

APPENDIX C.1

PCB TMDL ACTION PLAN

**FOR
FORT MYER & HENDERSON HALL INSTALLATIONS
FORT MYER, VIRGINIA**

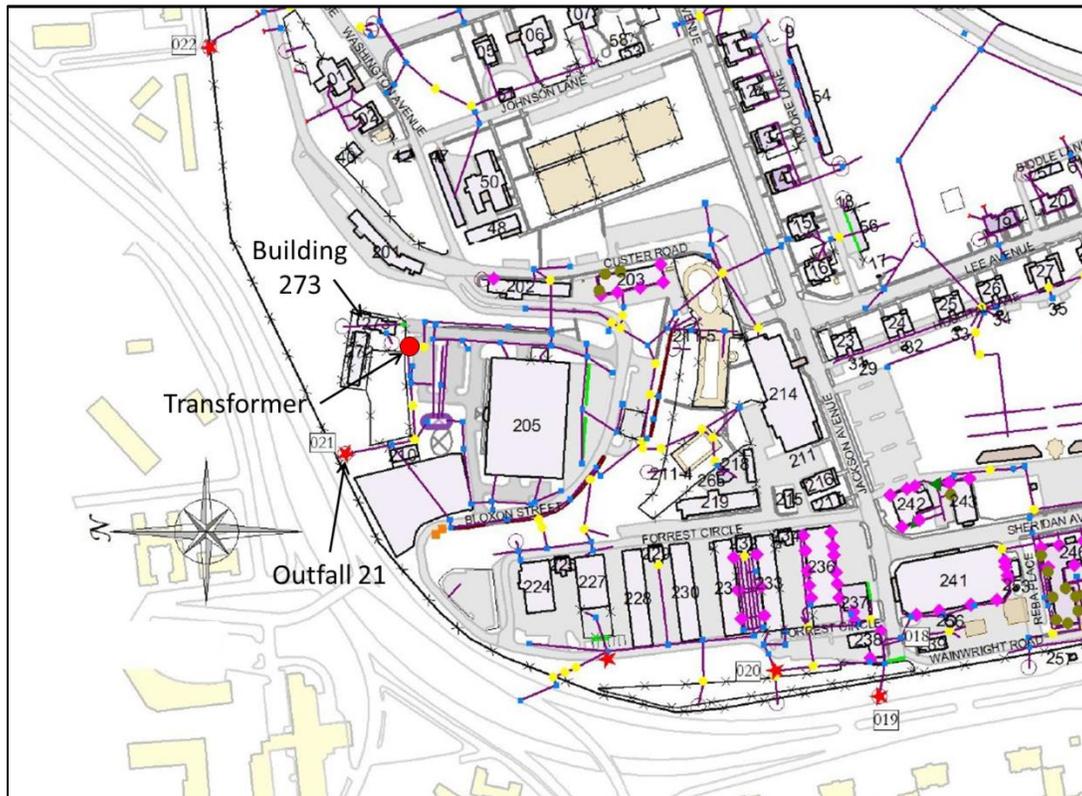
Building 270/273: The transformer at Building 273 was listed as Building 270 Dog Kennels in the 1996 Inventory. The 2016 site inspection found some corrosion at the bottom of the transformer and some staining of indeterminate source. Since the nature and age of the staining could not be determined, this site could not be ruled out as a potential source of PCB impacts, stormwater runoff characterization is recommended. This site is included in the proposed sampling analysis plan.

Stormwater discharges from the area surrounding Building 270/273 Dog Kennels transformer that was observed with unidentified staining is treated by structural stormwater BMPs. The transformer is surrounded by a well-vegetated, grassy area, which would limit the transport of any soil that may be or become contaminated by PCBs. This area drains to a dry detention basin, which promotes settling of sediments.

Site access for sampling will be coordinated with facility staff. Stormwater runoff will be collected at stormwater Outfall 21 twice in one calendar year to assess the runoff from the area of the transformer at Building 270/273 (Dog Kennels). **Figure 3** below shows the transformer and Outfall 21 locations.

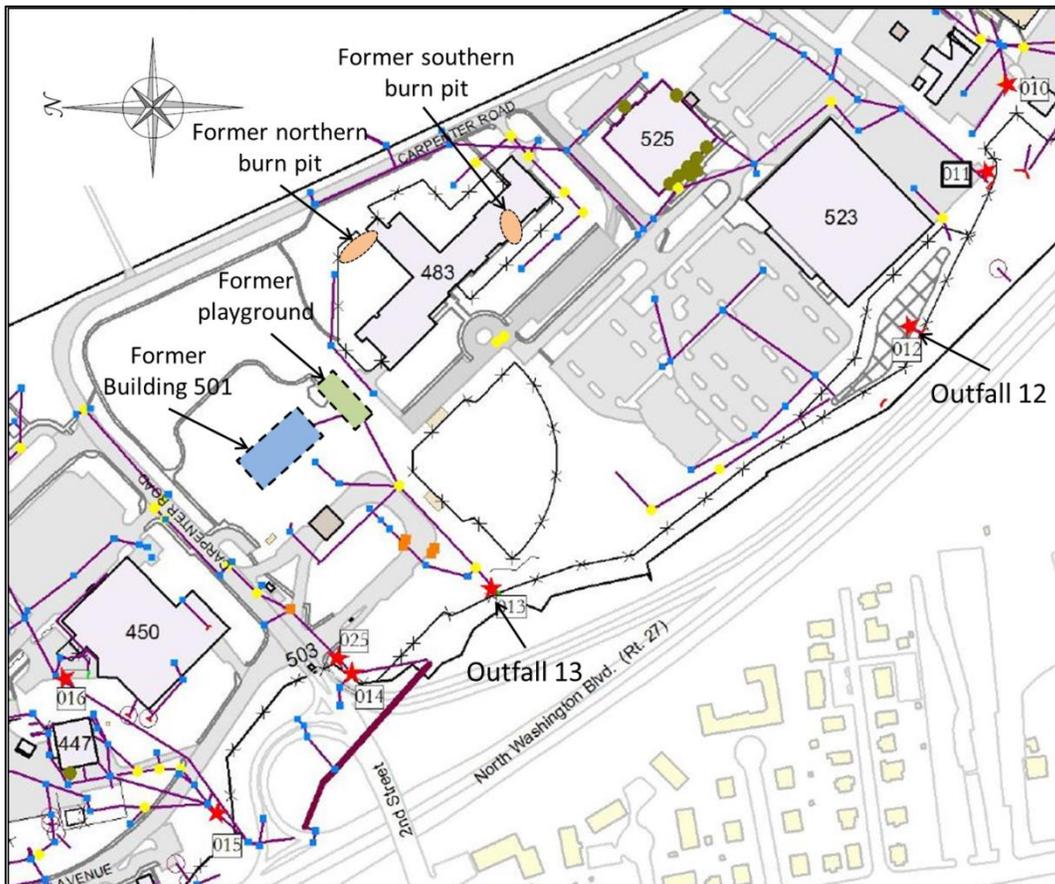
Child Development Center and surrounding areas: The Child Development Center (CDC) (Building 483) is a new building that was constructed in the location of former burn areas at the Installation. These areas, known as the north and south burn areas, were historically used to burn waste materials such as wood and paper. Sampling conducted of these areas as part of remediation efforts found a maximum PCB concentration of 34 ppm, exceeding the USEPA PCB cleanup levels for non-restricted access areas (10 ppm).

The area to the north and northwest of Building 483 was formerly occupied by Building 501 and a playground area. The building and playground have been removed and these areas are currently grassy fields. The playground area was remediated in 1984-1985, when 200 cubic feet of PCB-impacted sand and soil were excavated and replaced with clean fill (clay and loose sand). The area northeast of Building 501 was a former sanitary landfill that contained PCB-impacted soils. Surface soil samples collected in 1984 found a concentration of 2.24 ppm, which is below the USEPA PCB cleanup levels for non-restricted access areas (10 ppm).

Soil samples were also previously collected from the area east of former Building 501 that is currently occupied by a parking lot for the Rader Health Clinic and ballfield area. None of these samples had PCB concentrations that exceeded the USEPA PCB cleanup levels for non-restricted access areas (10 ppm).

This area is not anticipated to be a significant source of PCBs in stormwater runoff given that PCB-impacted soils in these areas were either remediated or concentrations were found to be below EPA cleanup levels, and that a substantial amount of construction and demolition has occurred in these areas. However, given the large size of the area and the history of PCB impacts, stormwater runoff characterization is recommended and this site is included in the proposed sampling analysis plan.

The CDC (Building 483), which is in the location of the former south and north burn areas, has a large building that occupies most of the former burn areas and is surrounded by vegetated and paved areas. The area to the east of the CDC is mostly occupied by a large parking lot. The area to the north of the parking lot is a maintained ballfield, and the area to the north of the CDC, the former Building 501 and playground, is a well-vegetated area. Buildings and paved

Stormwater runoff will also be collected from stormwater Outfalls 12 and 13 twice in one calendar year to assess the area surrounding the CDC. **Figure 4** below shows the locations of the former northern burn pit, southern burn pit, Building 501, and playground.
